4MX Series Transmitters

Software Upgrade Via I.P. Connection Application Guide

597-4050-006, Revision B
12/12/07

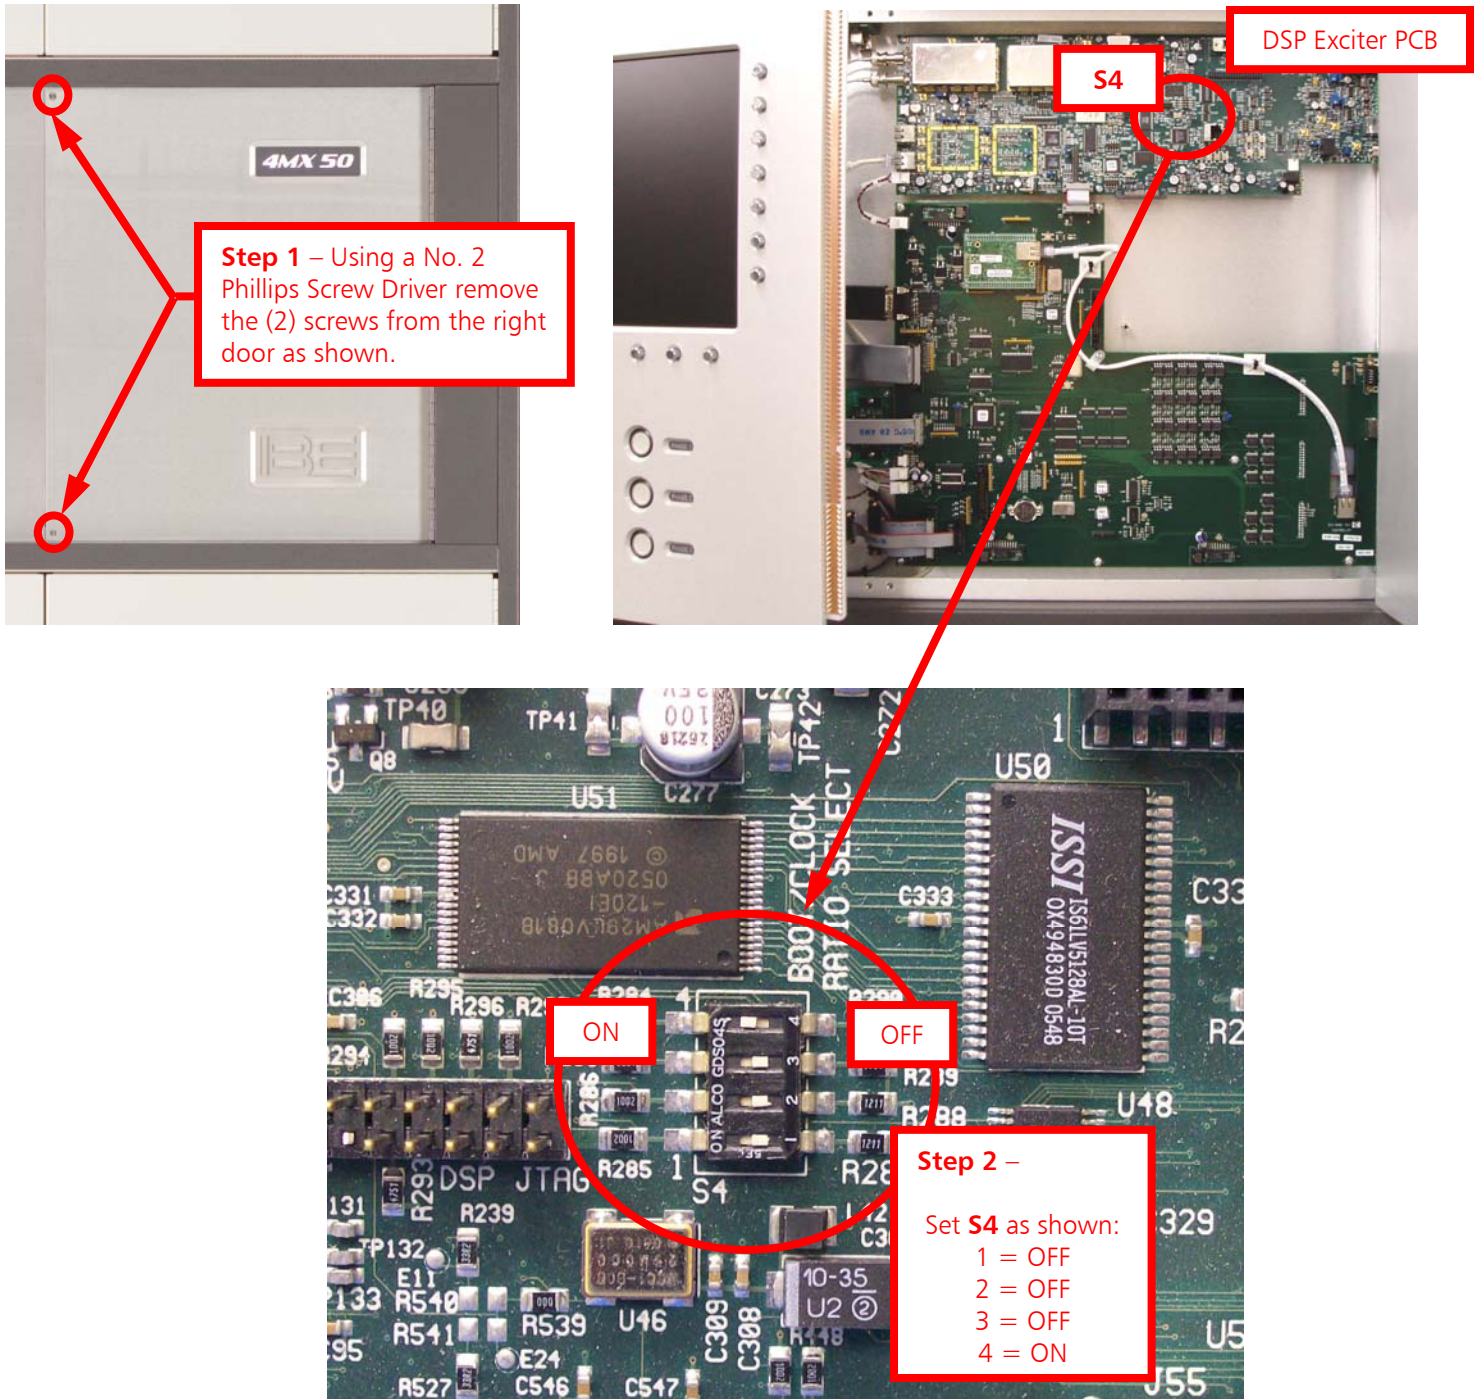
Figure 3 – DSP Exciter S4 Settings

If the DSP Exciter target is to be updated to version 46.X.X.X.X or greater, dip switch S4 must be changed or it will result in a DSP Exciter Board fault. S4 on the DSP Exciter needs to be set to 1=OFF, 2=OFF, 3=OFF, and 4=ON as shown below.

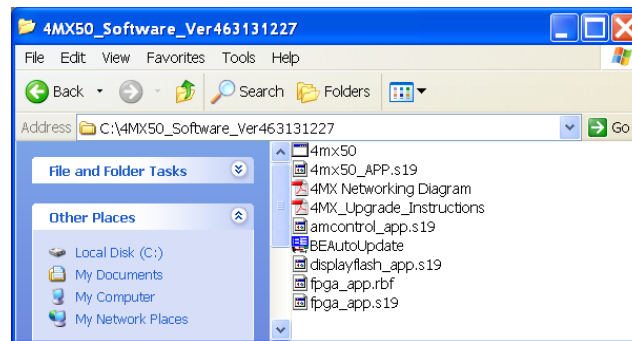
Figure 4 – 4MX Software Upgrade Files

Step 1 – Using Windows Explorer, copy all of the files from the 4MX Software Upgrade CD (or files downloaded from the B.E. Website) to a folder on the hard drive “C:\” of the personal computer that you are planning to use for the upgrade. Unzip the files (if they have been zipped) ensuring that all of the files remain in the “4MX Upgrade” directory.

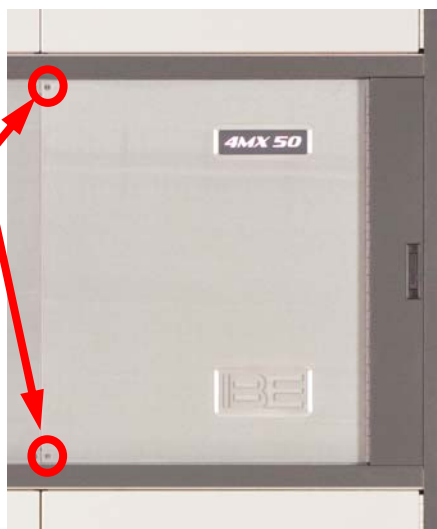
Step 5a – Using a No. 2 Phillips Screw Driver remove the (2) screws from the right door as shown.

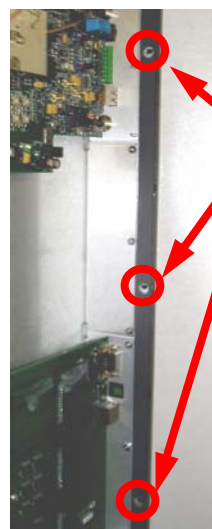
Step 5b – Using a No. 2 Phillips Screw Driver remove the (3) screws from the hinge area as shown

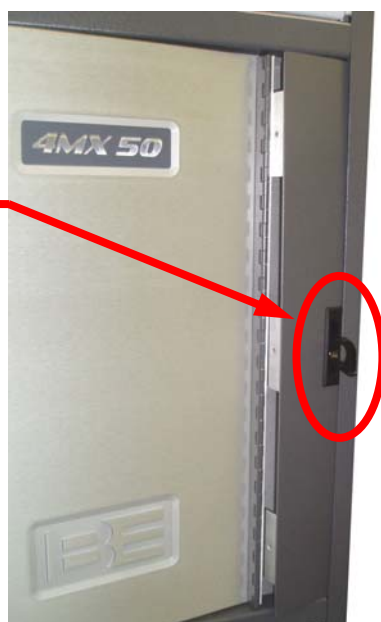
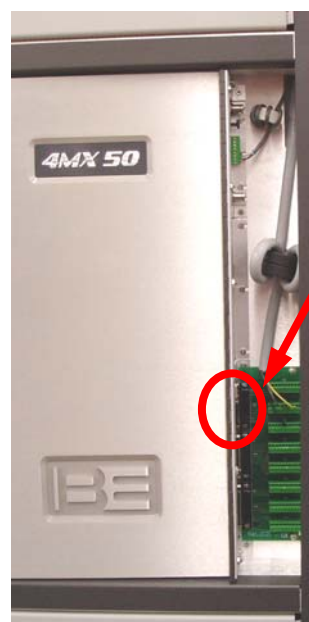
Figure 8 – Remote Control I/O Access Panel Removal

Step 5c – Use the fold-out handle to remove the Remote Control I/O and Audio Input Access Panel

Ethernet Port

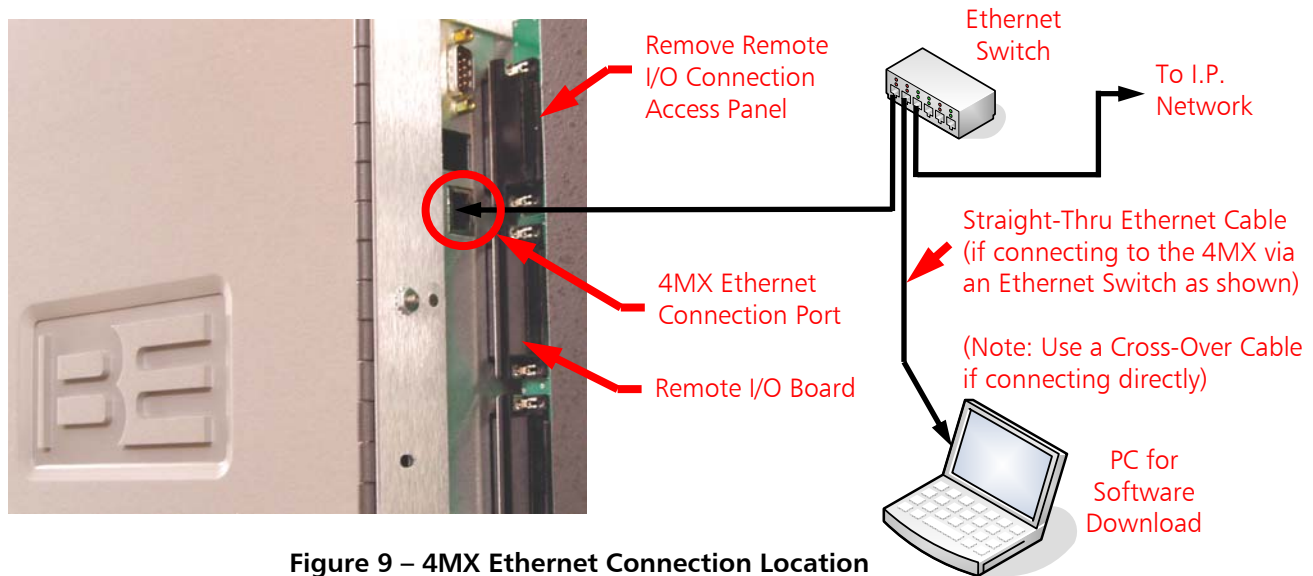
Figure 9 – 4MX Ethernet Connection Location

Step 6 – Next, connect an Ethernet cable from your PC to the 4MX. If connecting to the transmitter via a network switch or hub, use a Straight-Thru Ethernet cable as illustrated. If connecting directly from the PC to the 4MX, use a Cross-Over Ethernet cable (in high RF environments route and wrap the cable through a ferrite ring).

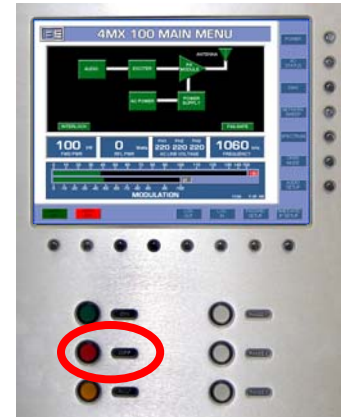
Figure 11 – Turn the RF Output Power OFF

Step 9 – Turn the transmitter's **RF Output Power OFF** either from the Main Menu or by depressing the front panel button.

NOTE: The 4MX Transmitter's RF Output **MUST** be OFF during the entire Software Upgrade Process!

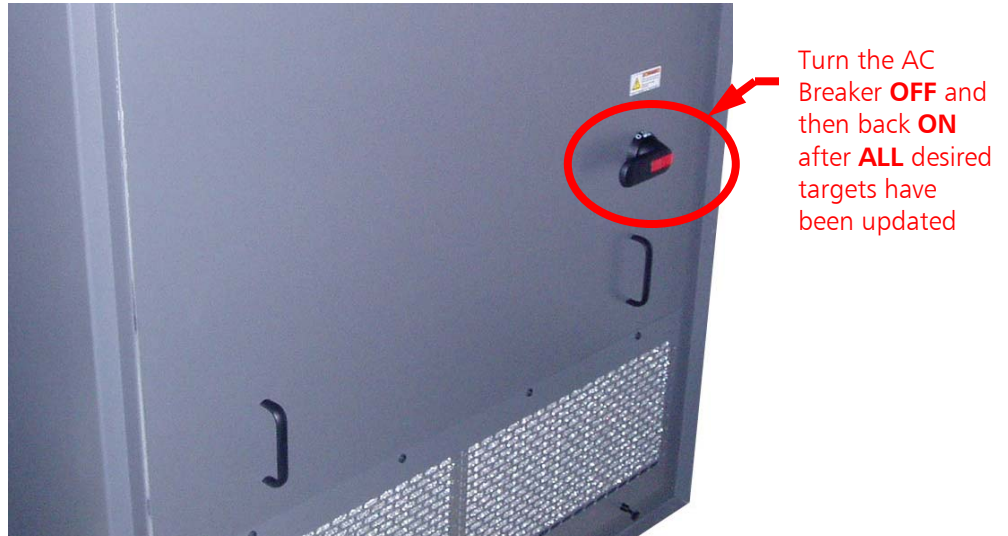
Figure 15 – Turn the 4MX AC Breaker OFF then back ON after ALL Targets Have Been Updated

- Step 13** – Repeat **Steps 10 thru 12** for each “**Target**” to be updated.
- Step 14** – Close the **BEAutoUpdate** application by selecting “**Quit**”.
- Step 15** – After **ALL** desired targets have been updated, you **MUST** then turn the Transmitter’s AC Power **OFF**, and then back **ON** for the software updates to take affect.

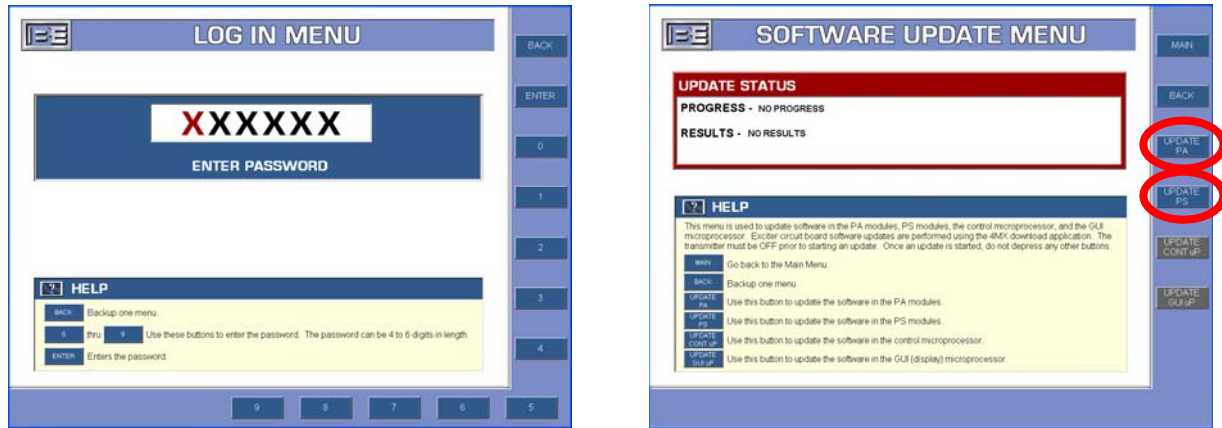
Figure 19 – Software Update Menu

Step 18 – After selecting **SOFTWARE UPDATE**, the login screen will appear. Only the “Chief Engineer” login (factory default is **123456**) has permission to the Software Update Menu.

Select **UPDATE PA** to update software in all of the 4MX PA Modules.

Select **UPDATE PS** to update software in all of the 4MX PS Modules.

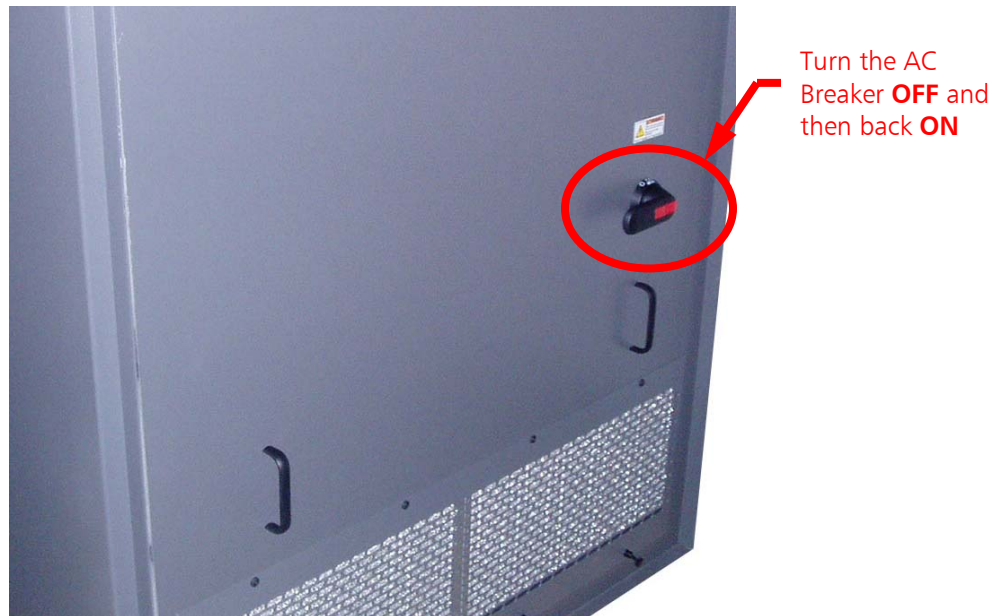
Figure 20 – Turn the 4MX AC Breaker OFF then back ON

Step 19 – Once all of the PA Modules and/or PS Modules have been updated, turn the Transmitter's AC Power OFF, and then back ON for the software updates to take affect.
